# YOUR INSPECTION REPORT

1691 Taughannoch Blvd  
Trumansburg, NY

Saturday, April 15, 2017

RE: Report No. 1304  
1691 Taughannoch Blvd  
Trumansburg, NY

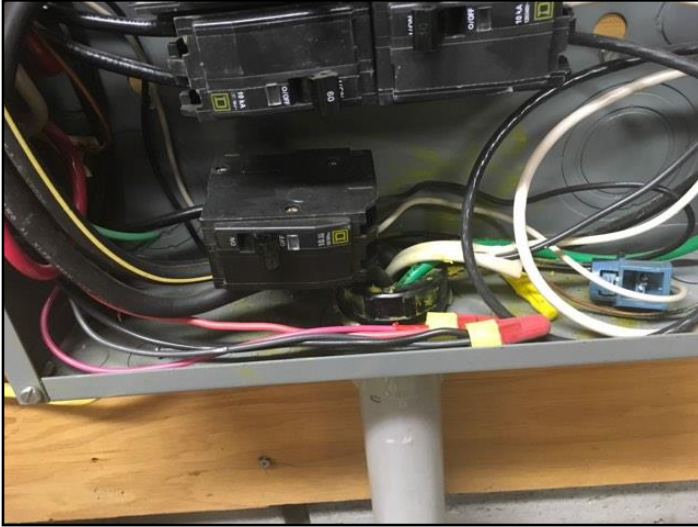
14.

**2. Condition:** • Abandoned breaker. This breaker once controlled a heater for the footer drains around the house. It was never used and has been decommissioned.

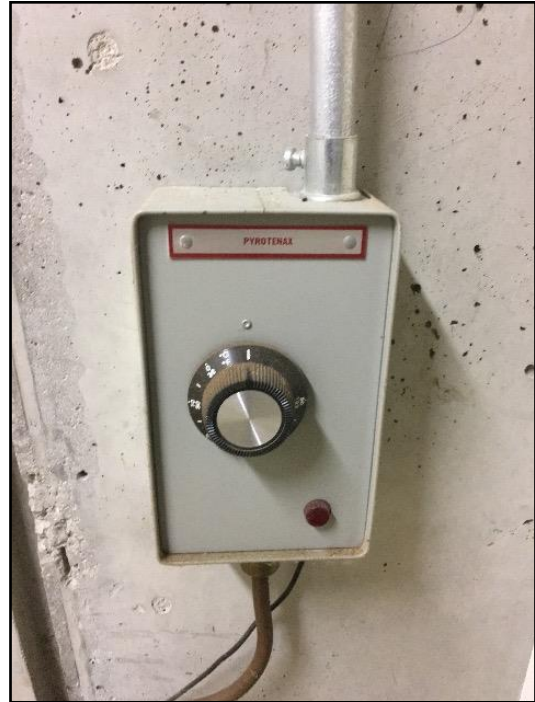
15. Footer drain heater

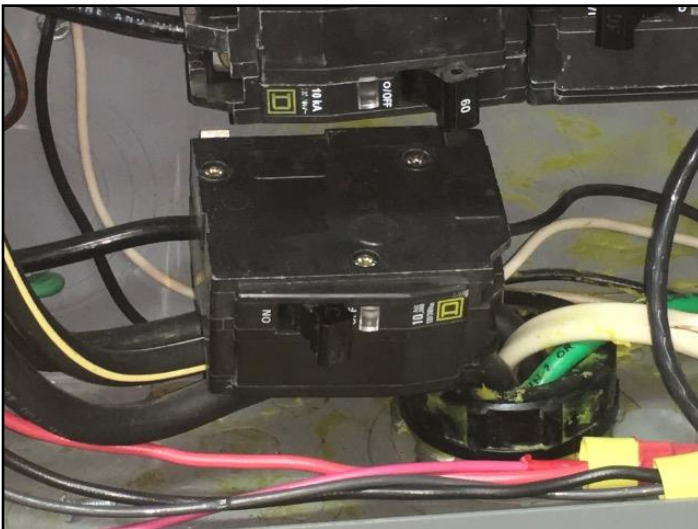
16. Decommissioned breaker

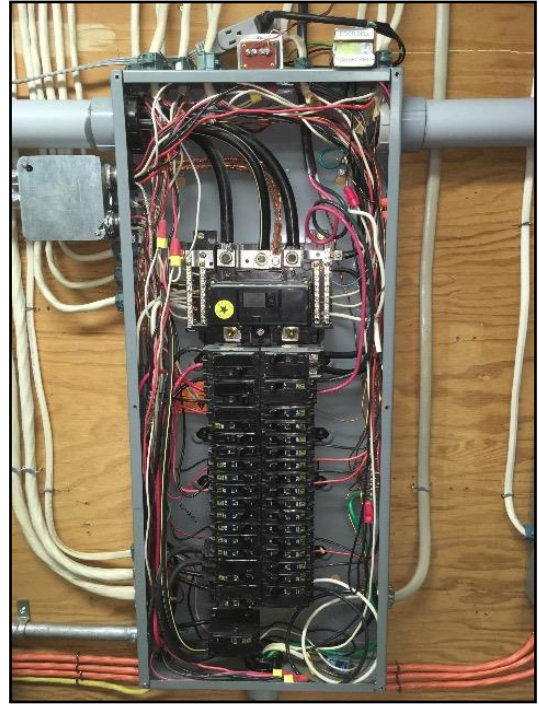
17. Decommissioned breaker

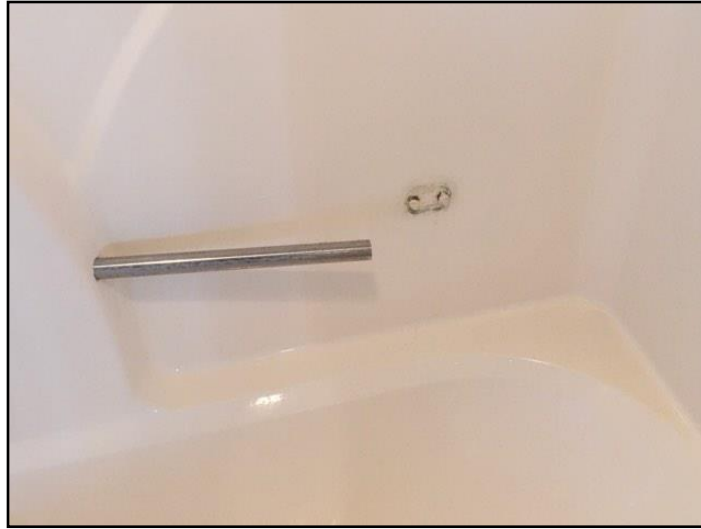
25.

**3. Condition:** • Grab bar broken in guest bathroom.

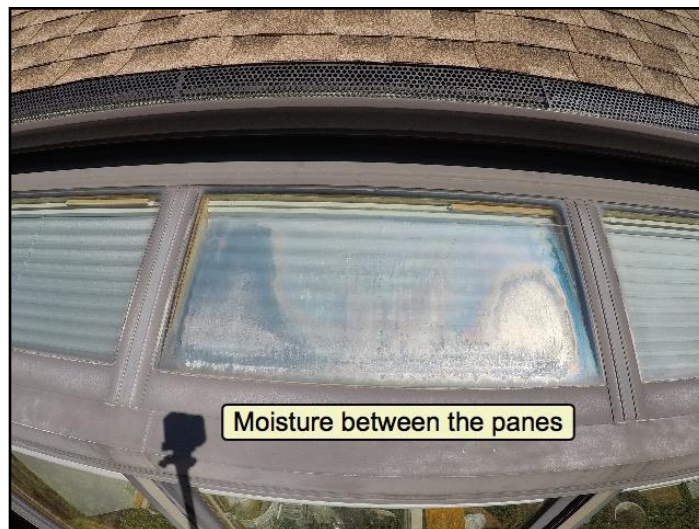
**4. Condition:** • [Lost seal on double or triple glazing](#)

The second skylight from the right side in the solarium area of the kitchen has lost it's seal and there is moisture between the panes.

26. Lost seal on double or triple glazing

**Task:** Repair or replace

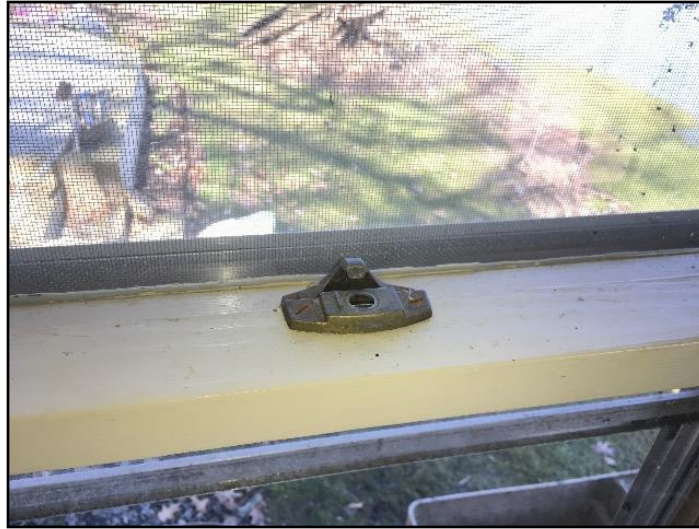
**5. Condition:** • [Broken](#)

The lock on the north side window of the beach house was broken.

27. Broken lock

**Task:** Replace

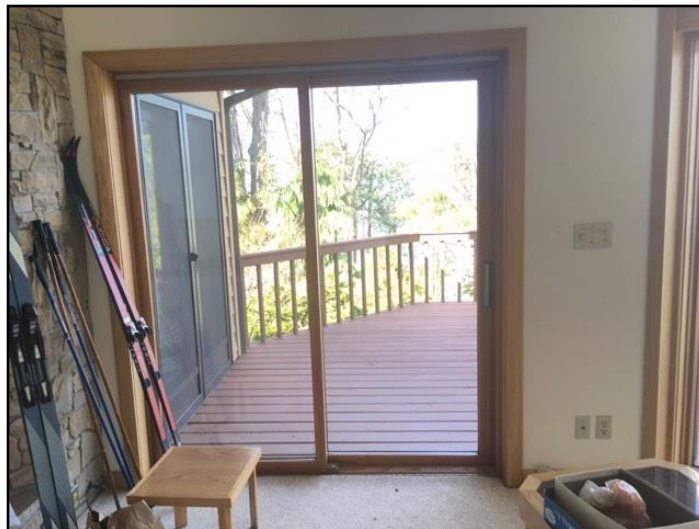
28.

**6. Condition:** • Left side sliding door sticks.

**Task:** Repair

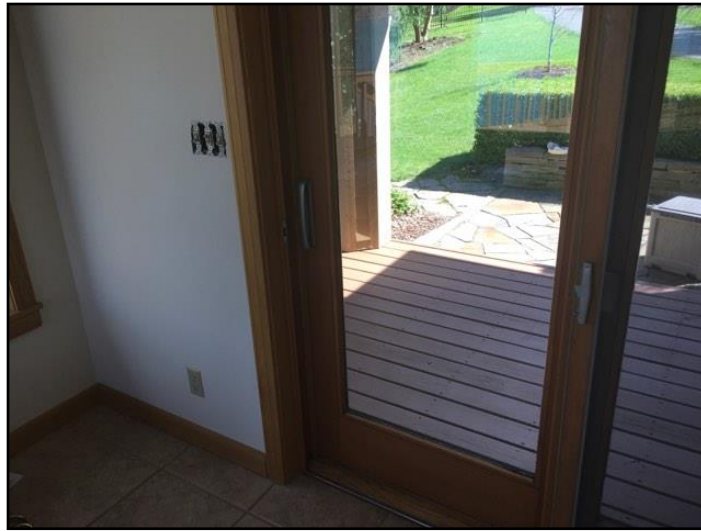
**7. Condition:** • Does not latch properly

The sliding door in the kitchen dining area did not latch properly.

29. Does not latch properly

**Task:** Repair

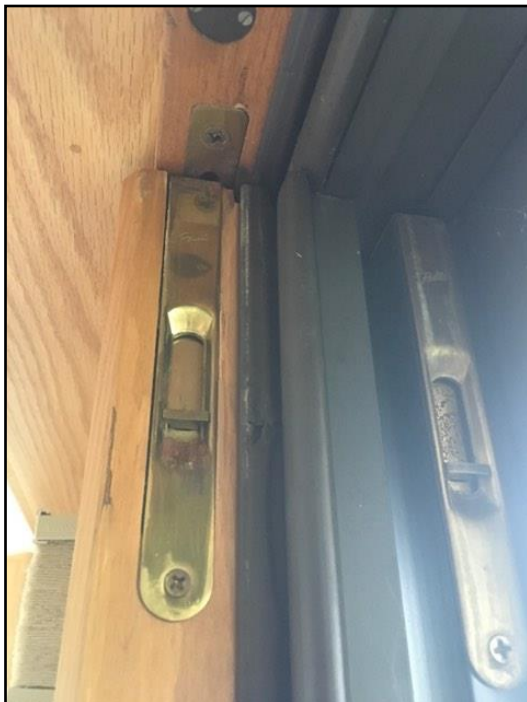
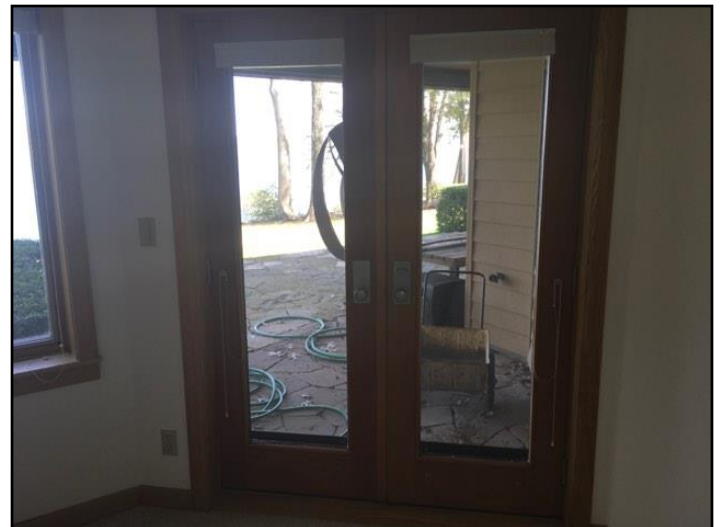
**8. Condition:** • Does not latch properly

30. Does not latch properly

31. Does not latch properly

**Task:** Repair

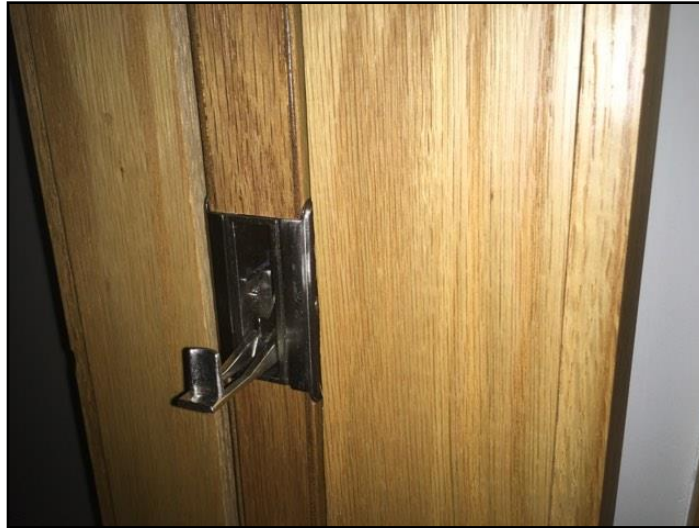
32.

**10. Condition:** • The pull on the hall pocket door was installed up side down.

**Task:** Repair

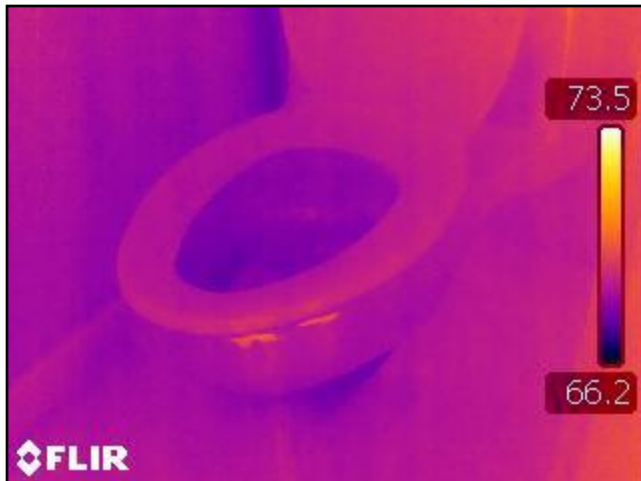
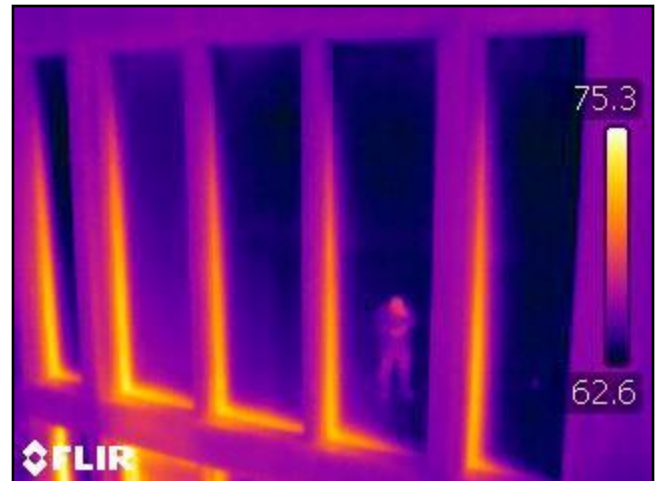
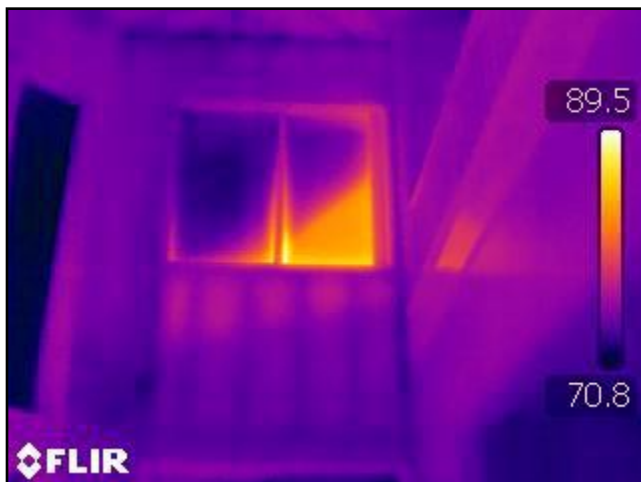
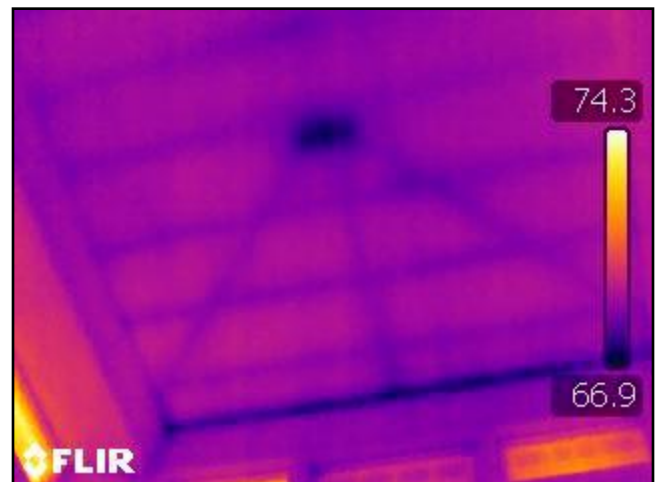
**General:** • There were no major defects in insulation or water infiltration found in the infrared inspection. In these infrared images lighter colors indicate warmer areas, darker colors indicate cooler areas. Colors and range are relative to each image.

**Note:** There were no gaps in insulation in side walls or ceilings throughout the house. Windows were without signs of water intrusion around the frames, and most have their seal intact. (See kitchen skylight for exception.)

33. No leaks

34. Good windows

35. Even insulation

36. Even insulation
