# YOUR INSPECTION REPORT

1691 Taughannoch Blvd  
Trumansburg, NY

Saturday, April 15, 2017

RE: Report No. 1304  
1691 Taughannoch Blvd  
Trumansburg, NY

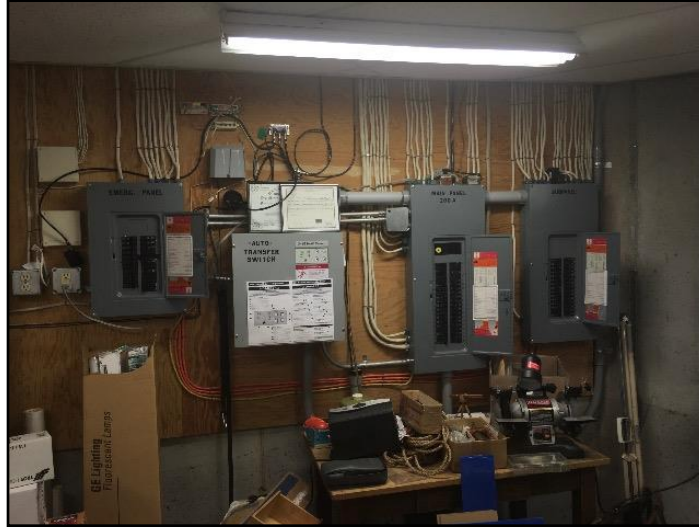
13. *Electrical utilities*

**General:** • Very orderly.

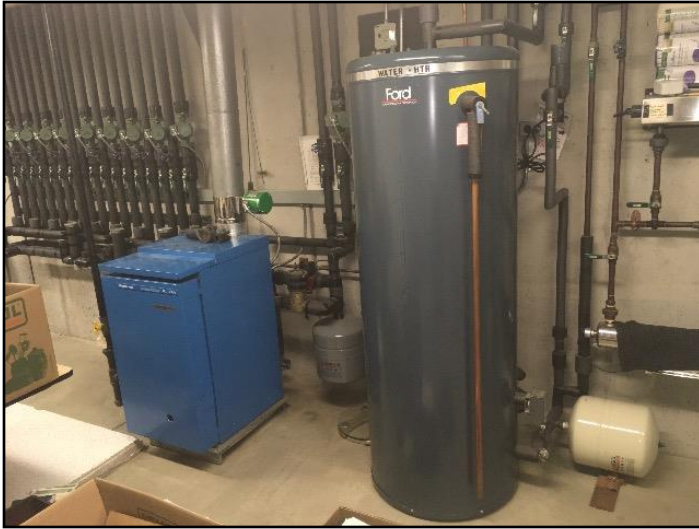
18. Boiler

I include photos of this system because it is one of the most orderly boiler systems I have found. It is a thing of beauty to a home inspector.

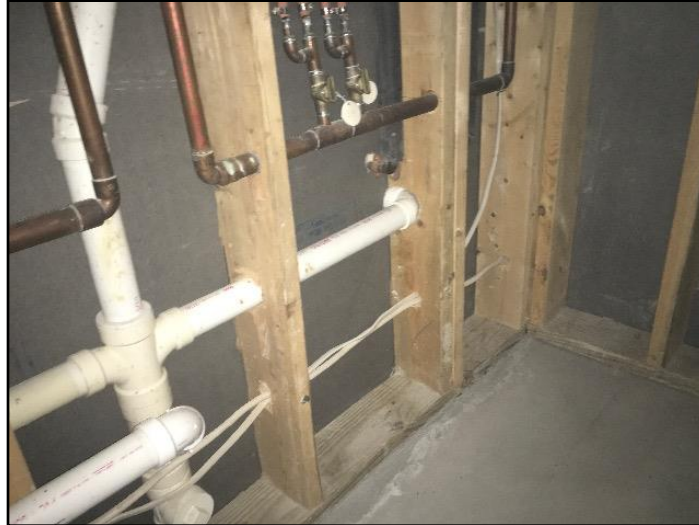
24. Expert installations

**General:** • The plumbing in this house appears to have been designed and installed by a highly skilled craftsman.
